# Manhole Inspection Summary

Manhole # S06GG2012MH

**Location** Address: **3509 SHELBURNE RD**

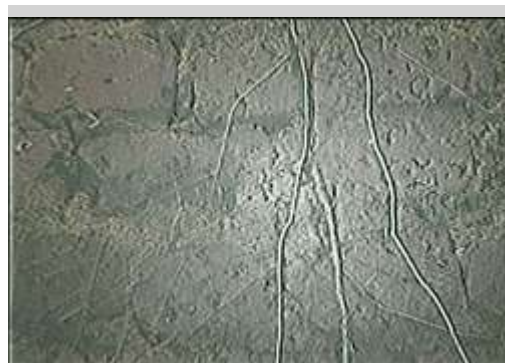
Defect

Barrel deterioration, root intrusion and infiltration.

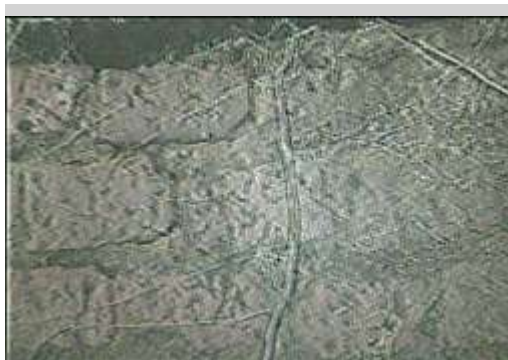
Defect

Adjustment root intrusion and infiltration.

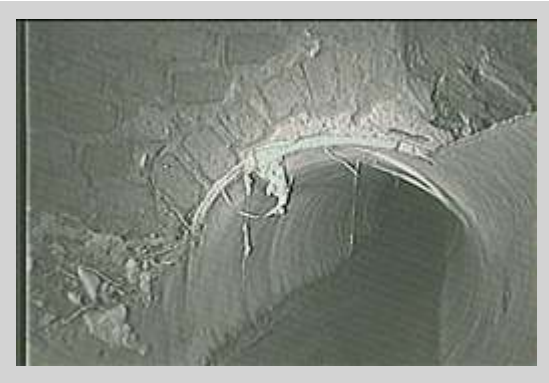
### 18 in. Circular Gravity Sewer Pipe Out @ 12 O'Clock

Pipe Material: **Unknown** ☒ Pipe Lined

Infiltration: **None** Pipe Seal Cond: **Unknown**

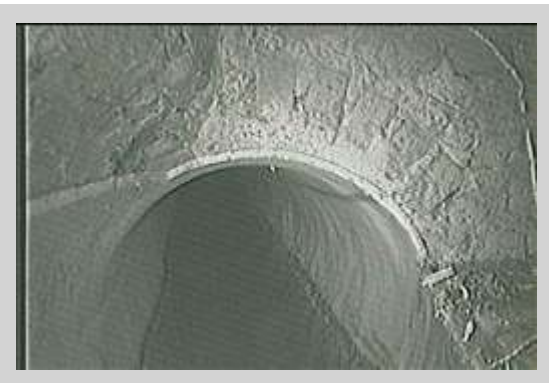
### 18 in. Circular Gravity Sewer Pipe In @ 6 O'Clock

Infiltration: **None** Pipe Seal Cond: **Cracked**
